## TECHNICAL BULLETIN

MG TF

**No:** TB0085 Issue 1

HEADER SEAL MODIFICATION – A POST FIXING

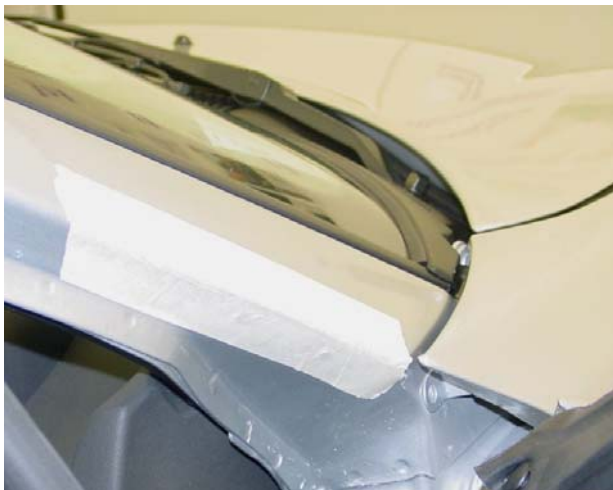
1

1. Referring to workshop repair [76.31.85](#) remove old seal.
2. Remove any traces of adhesive or road debris from the A post area.
3. Apply a 50mm wide X 200mm long strip of masking tape to the lower A post as shown in illustration 1. Close door.

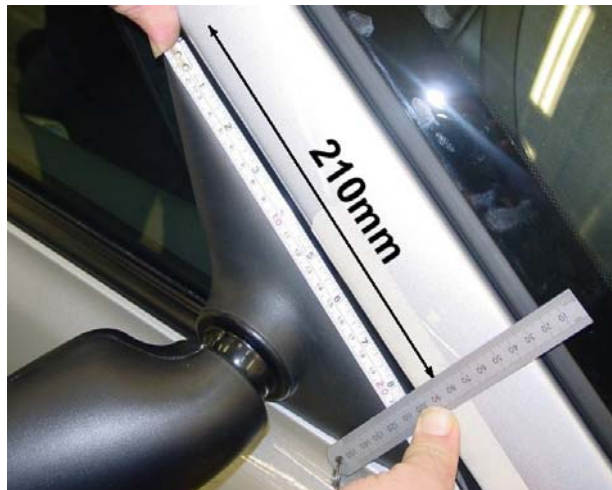
2

4. Using a tape measure and short steel rule, measure 210mm from the top of the cheater and make a pen mark on the adjacent masking tape (see illustration 2). Open door and continue mark into the underside of A post, ensuring that mark is kept parallel.

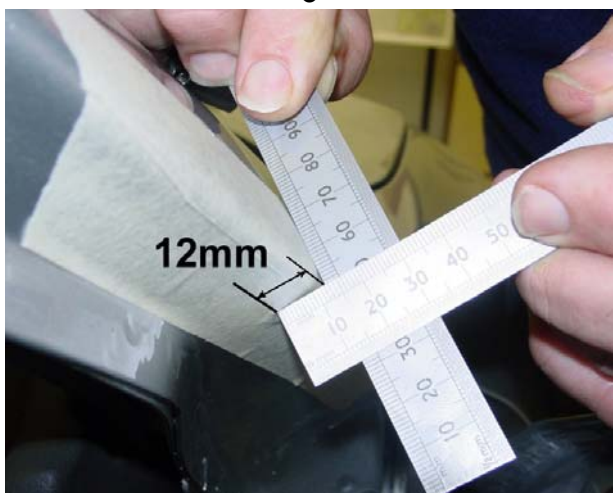
3

5. Using two rules, measure 12mm into the A post underside and make another pen mark where lines cross, this indicates position for the upper peg hole. Ensure that the rule being used as a straight edge rests on the flat portion of A post furthest away from the screen as shown in illustration 3.

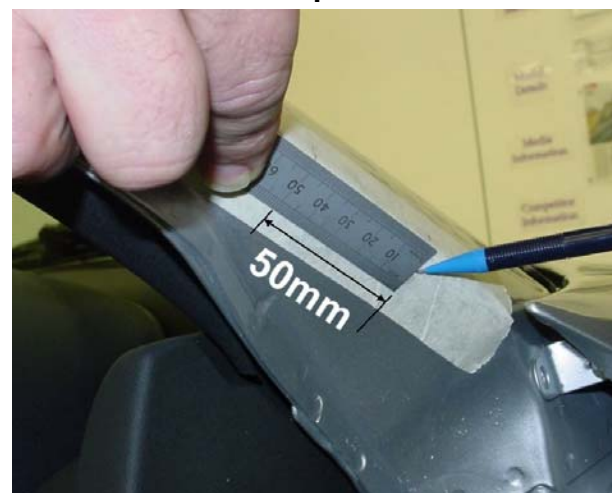
4

6. From the first peg hole mark, measure down 50mm and mark with pen (see illustration 4). Using the same (two rule) method as before make another mark 12mm into the A post underside to indicate position of the second peg hole.

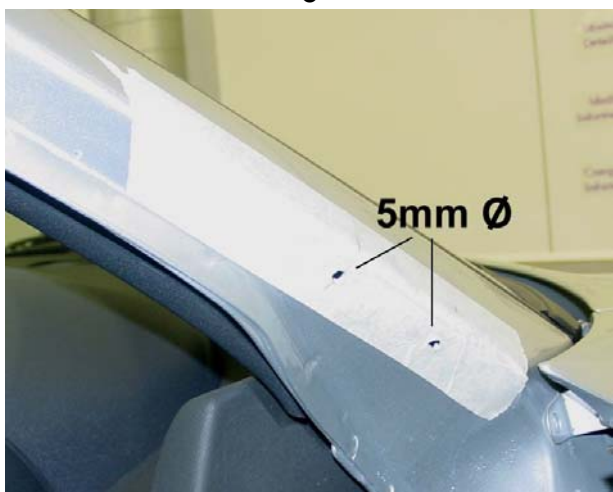
5

7. Protect inside of vehicle around door area from drilling debris. Using a 'sharp' drill, drill two 5mm holes in the A post underside in the marked positions (see illustration 5).
